2022/2023

Annual Environmental Report

Mid West Ports Authority

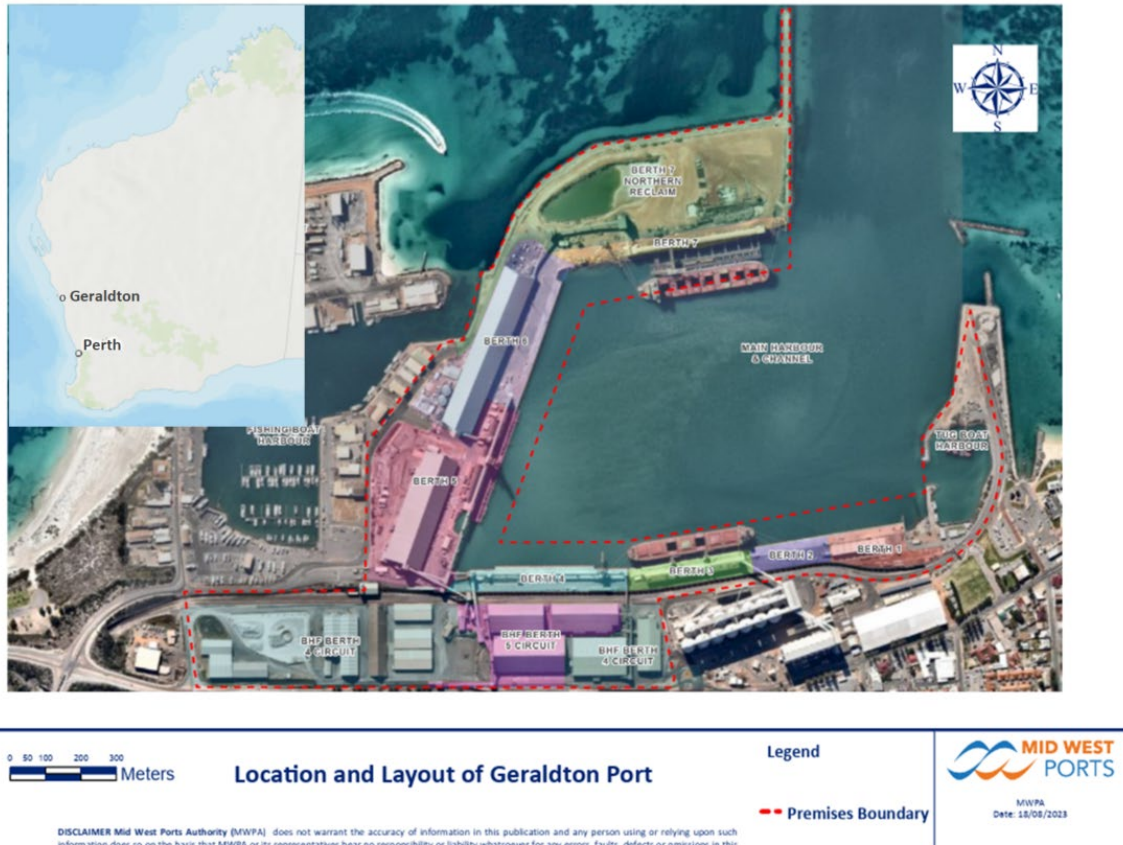
Figure 1 – Location and Layout of Geraldton Port

The Geraldton Port is situated in the Mid West region of Western Australia, approximately 430km north of Perth. Geraldton is the major hub for the region and services the mining, agricultural and fishing industries. The Geraldton Port consists of a Commercial Harbour comprised of seven bulk loading berths, as well as a Fishing Boat Harbour (FBH). These facilities are managed by the Mid West Ports Authority (MWPA). The location and layout of the Port of Geraldton is shown on Figure 1.

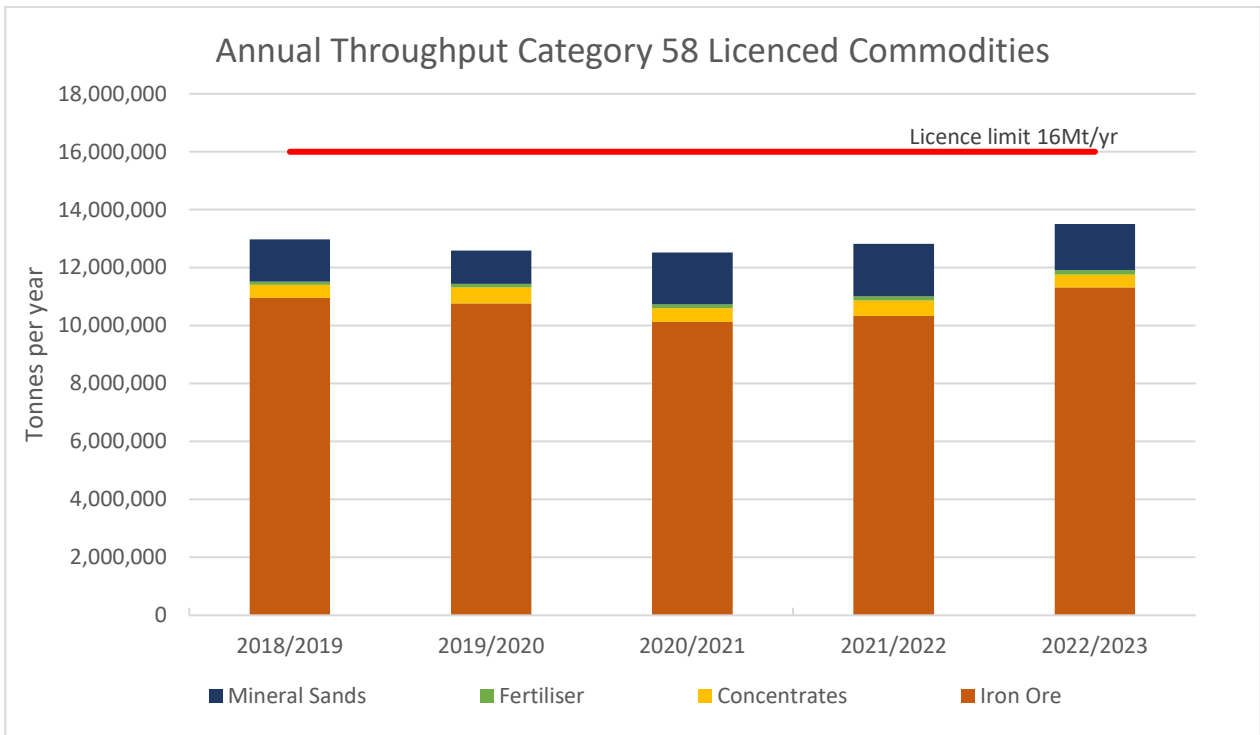
Figure 2 – Geraldton Port Annual Throughput by Commodity

A summary of annual throughput by Category 58 licenced commodity is provided in Figure 2.

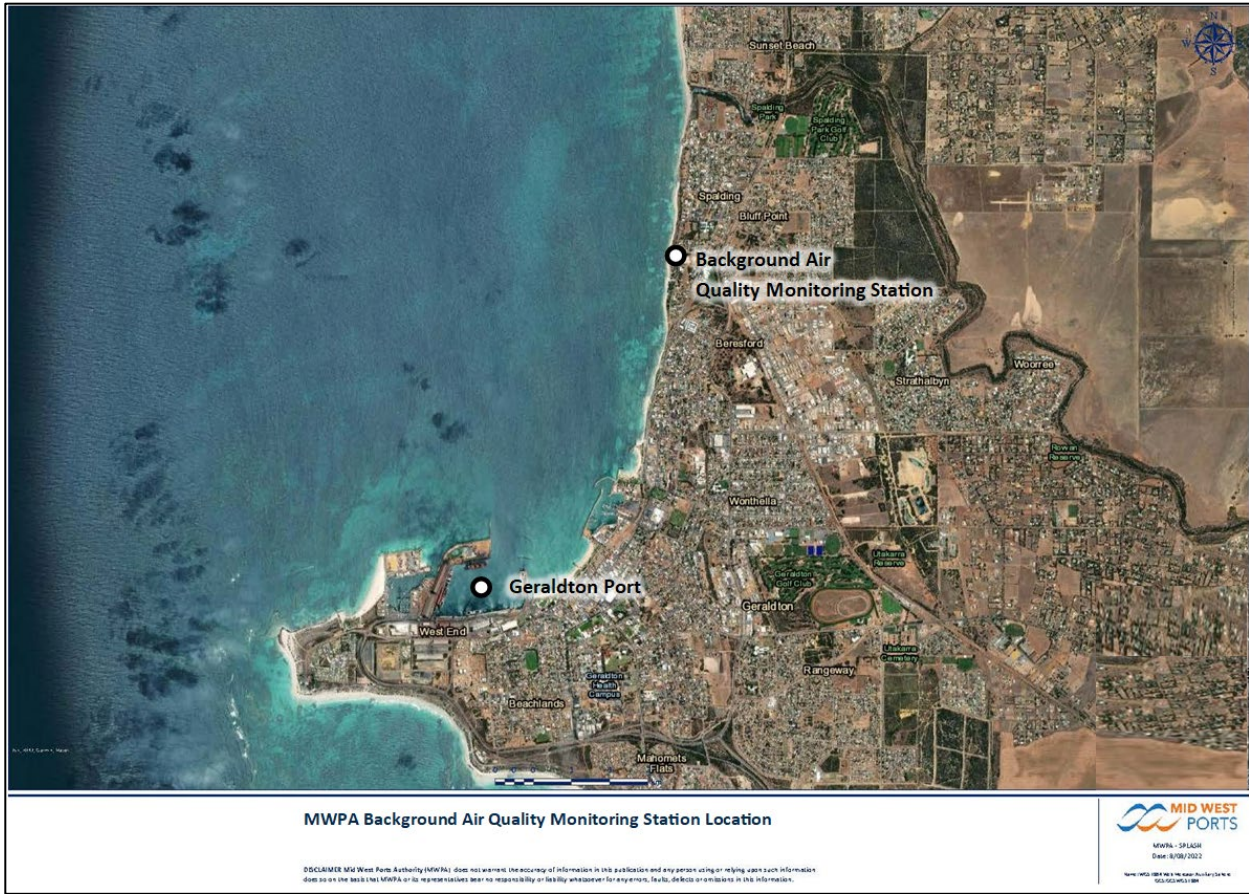
Figure 4 - MWPA Background Air Quality Monitoring Location

To better understand typical background dust levels commensurate with the Port's location, MWPA installed a real time PM₁₀ Beta Attenuation Monitor (BAM1020) in late 2013. The BAM is located approximately 4km north of the Port in the suburb of Bluff Point (Figure 4). This location was selected as the weather, vegetation and soil characteristics are proportionate with those experienced at the Port. It is positioned at a similar distance to the ocean, which may influence PM₁₀ concentrations through sea spray and salt. This site is referred to as Background BAM (BB) for the remainder of this report.

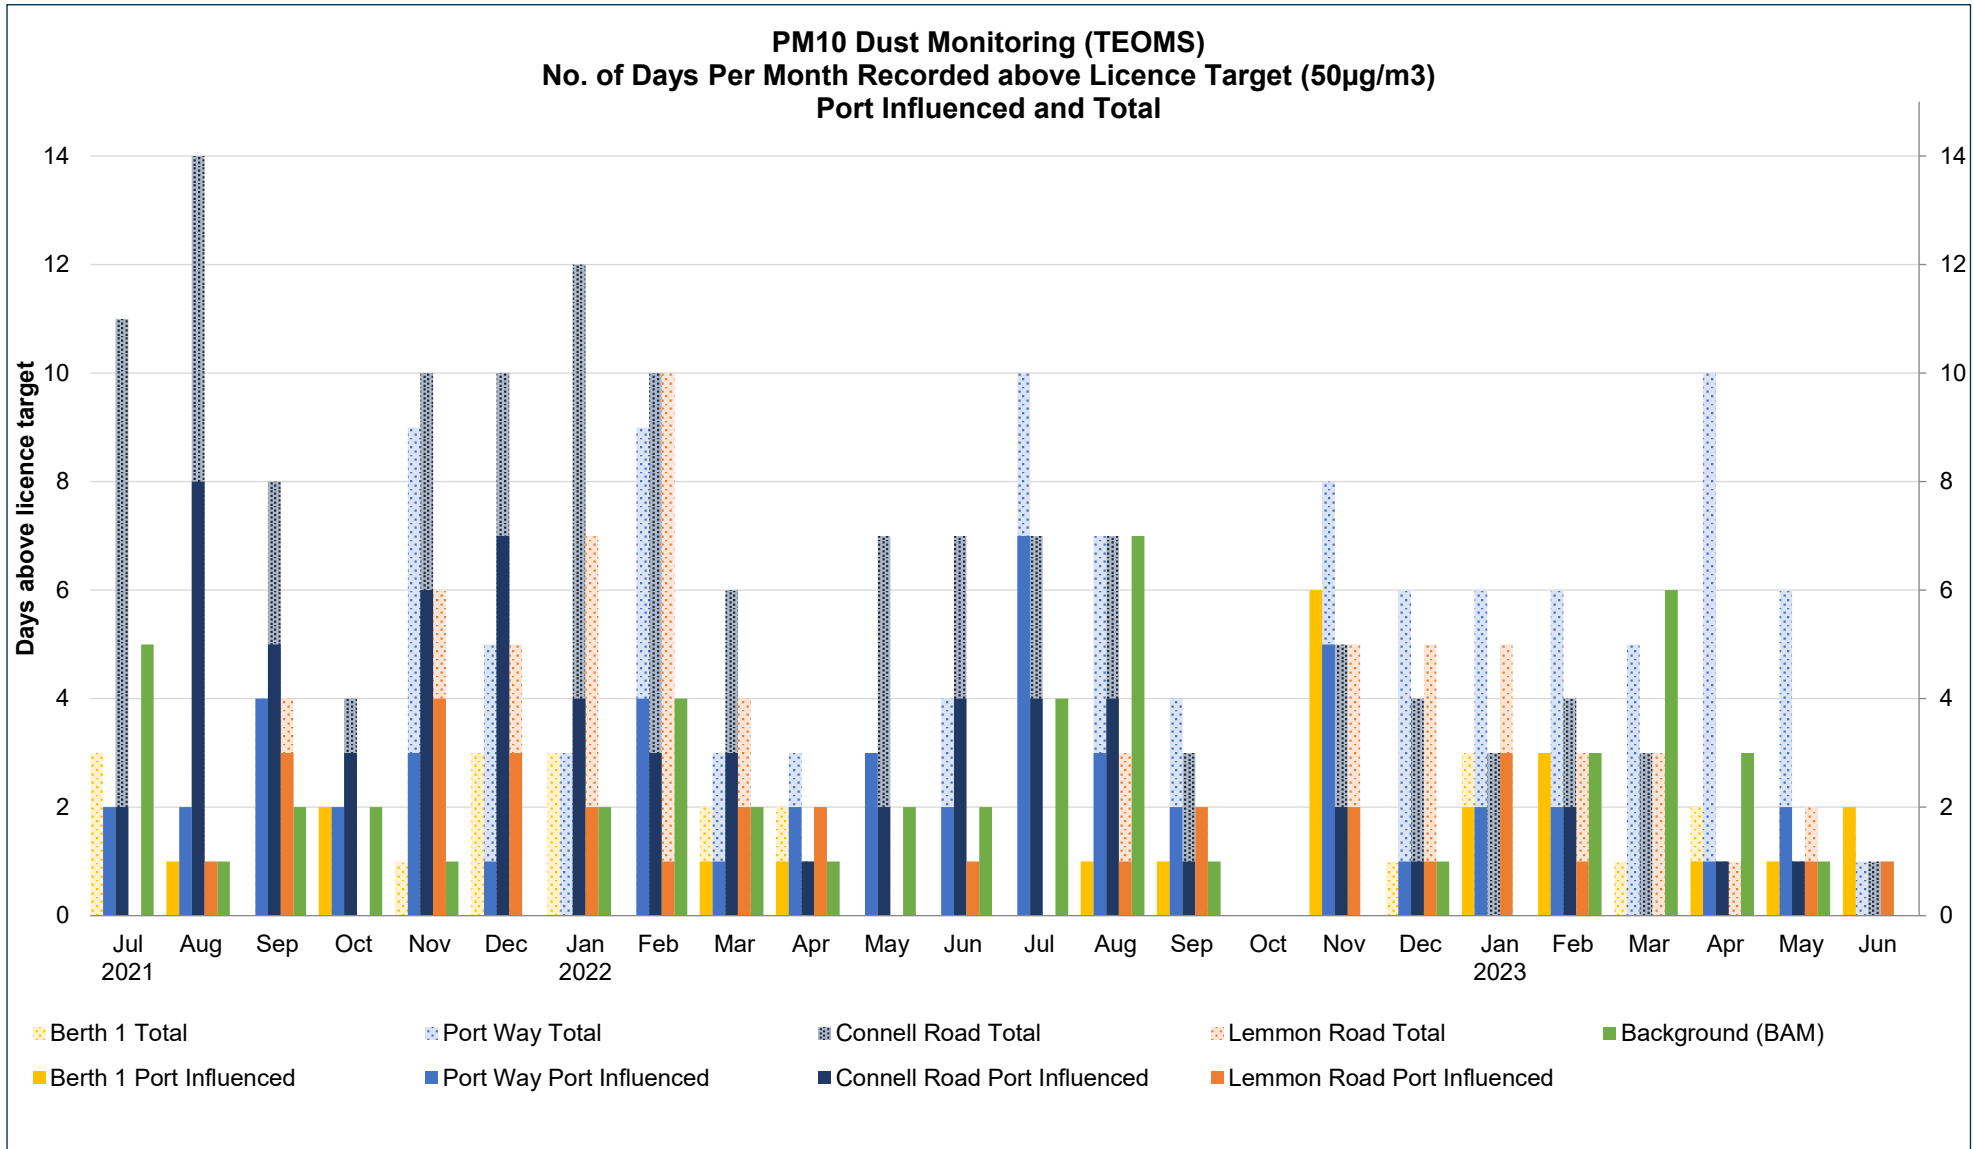
Figure 5 Port Influenced and Total days where 24-hour average exceeded Licence Target level for PM10

Figure 5 displays the port influenced days and total days per month real-time monitors exceeded the 24hour target in the 2021/2022 and 2022/2023 financial years.

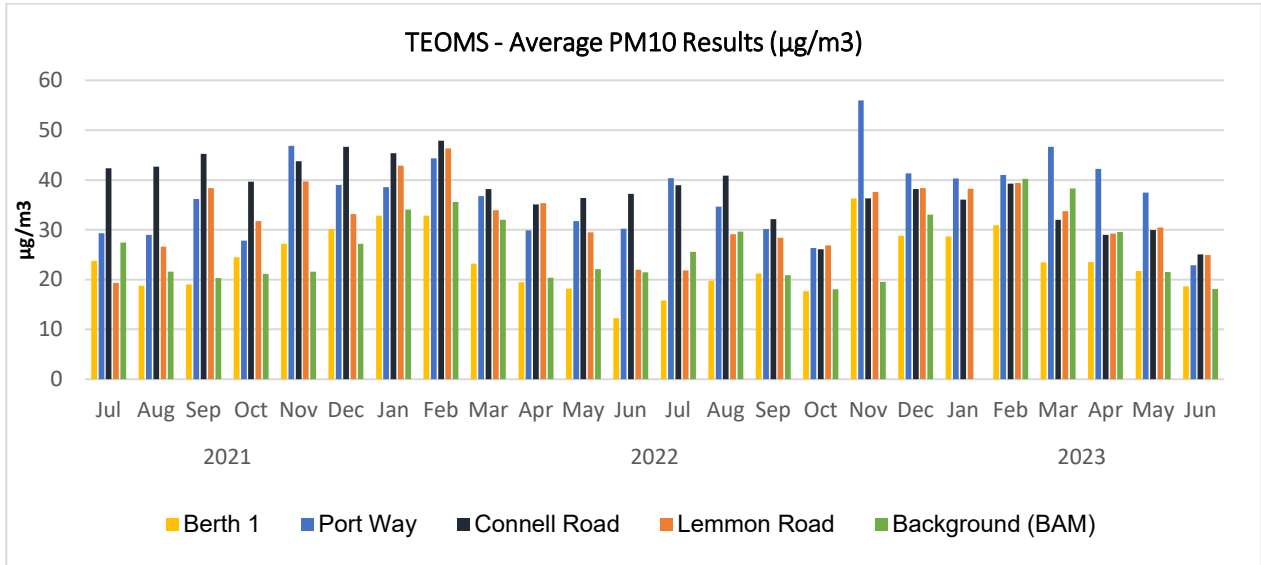
Figure 6 – Monthly Average PM10 levels during 2021/2022 and 2022/2023

Figure 6 displays the monthly average PM10 level recorded at each air quality monitoring station. The highest recorded monthly averages in 2022/2023 were recorded during November to February. Generally average dust levels were consistent with historical trends being highest over the harvest and summer period. Table 4 provides an overview of weather conditions including rainfall and maximum wind gusts experienced.

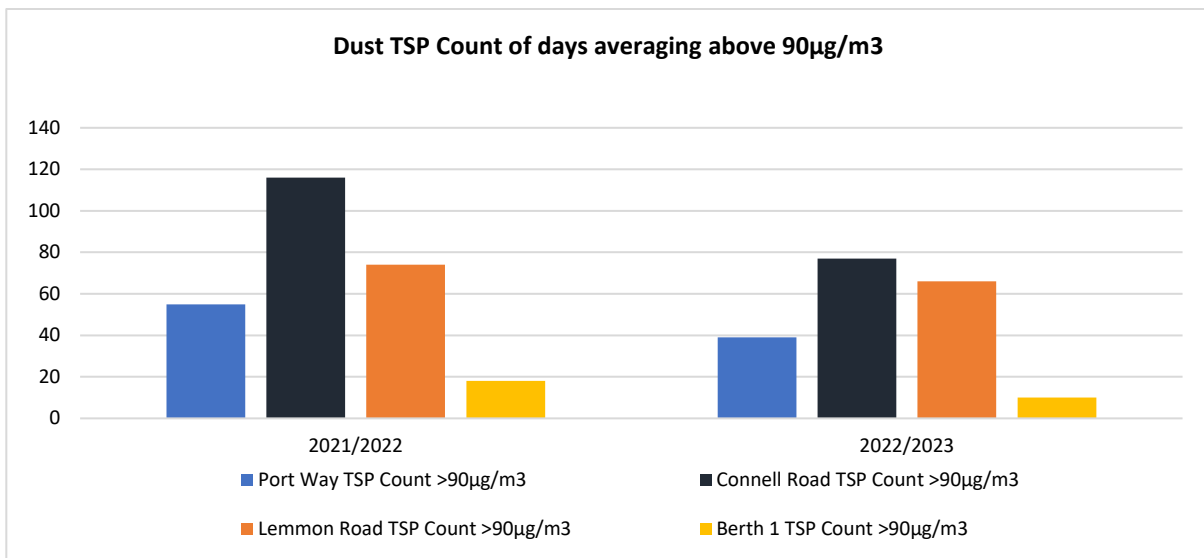
Figure 7 - Particulates as TSP for 2021/2022 and 2022/2023

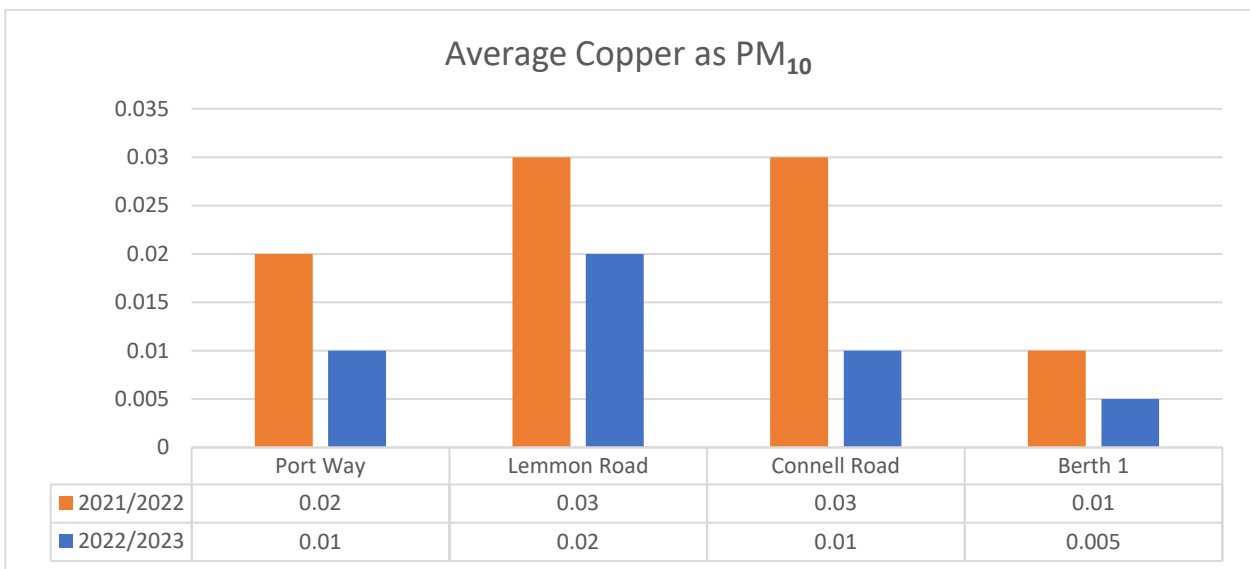
Figure 8 - HiVol Copper as PM₁₀ - Monitoring Summary

There was a reduction of the average levels of copper in 2022/2023 measured across all monitoring locations compared to 2021/2022. Figure 8 displays the annual average concentration of copper in HiVol samples for each monitoring location. Figure 9 displays each individual result for copper as PM₁₀ in 2021/2022 and 2022/2023.

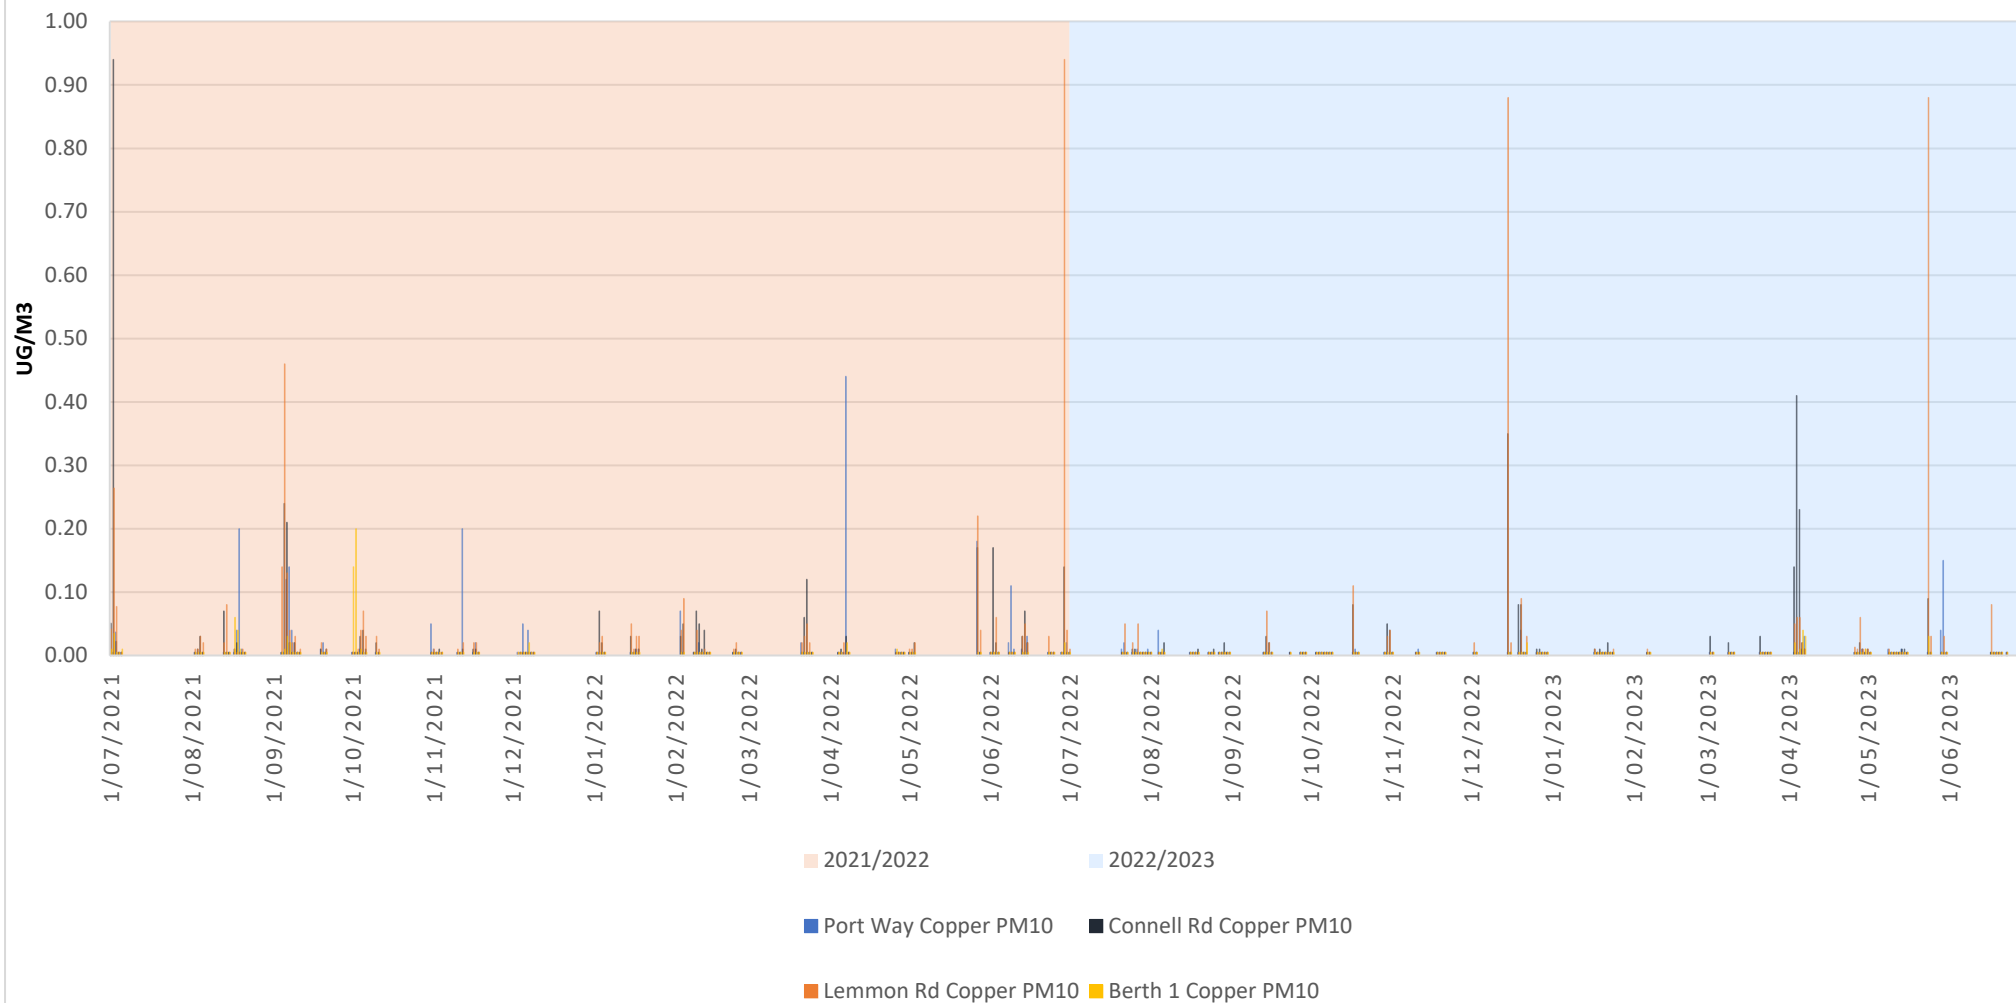
**COPPER PM10
ENVIRONMENTAL LICENCE TARGET = 1.0 UG/M3**

Figure 9 - 2021/2022 and 2022/2023 Copper Levels in Dust as PM10

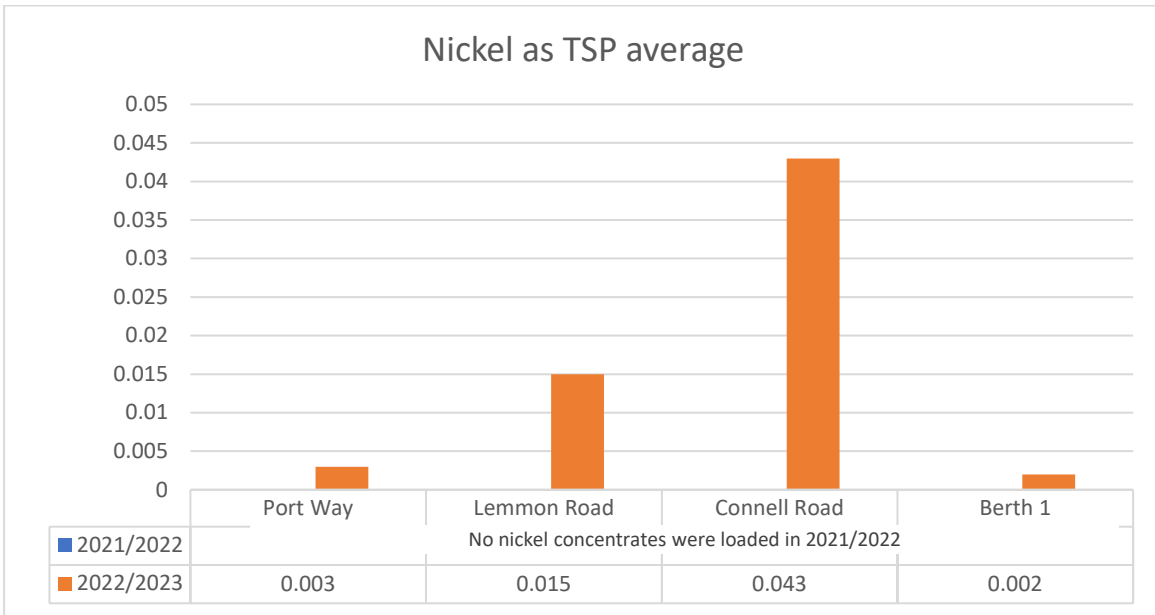
Figure 10 - HiVol Nickel – Annual TSP Average - Monitoring Summary

Figure 10 displays the annual average concentration of nickel in HiVol samples for each monitoring location. Figure 11 displays each individual result for nickel as TSP in 2021/2022 and 2022/2023.

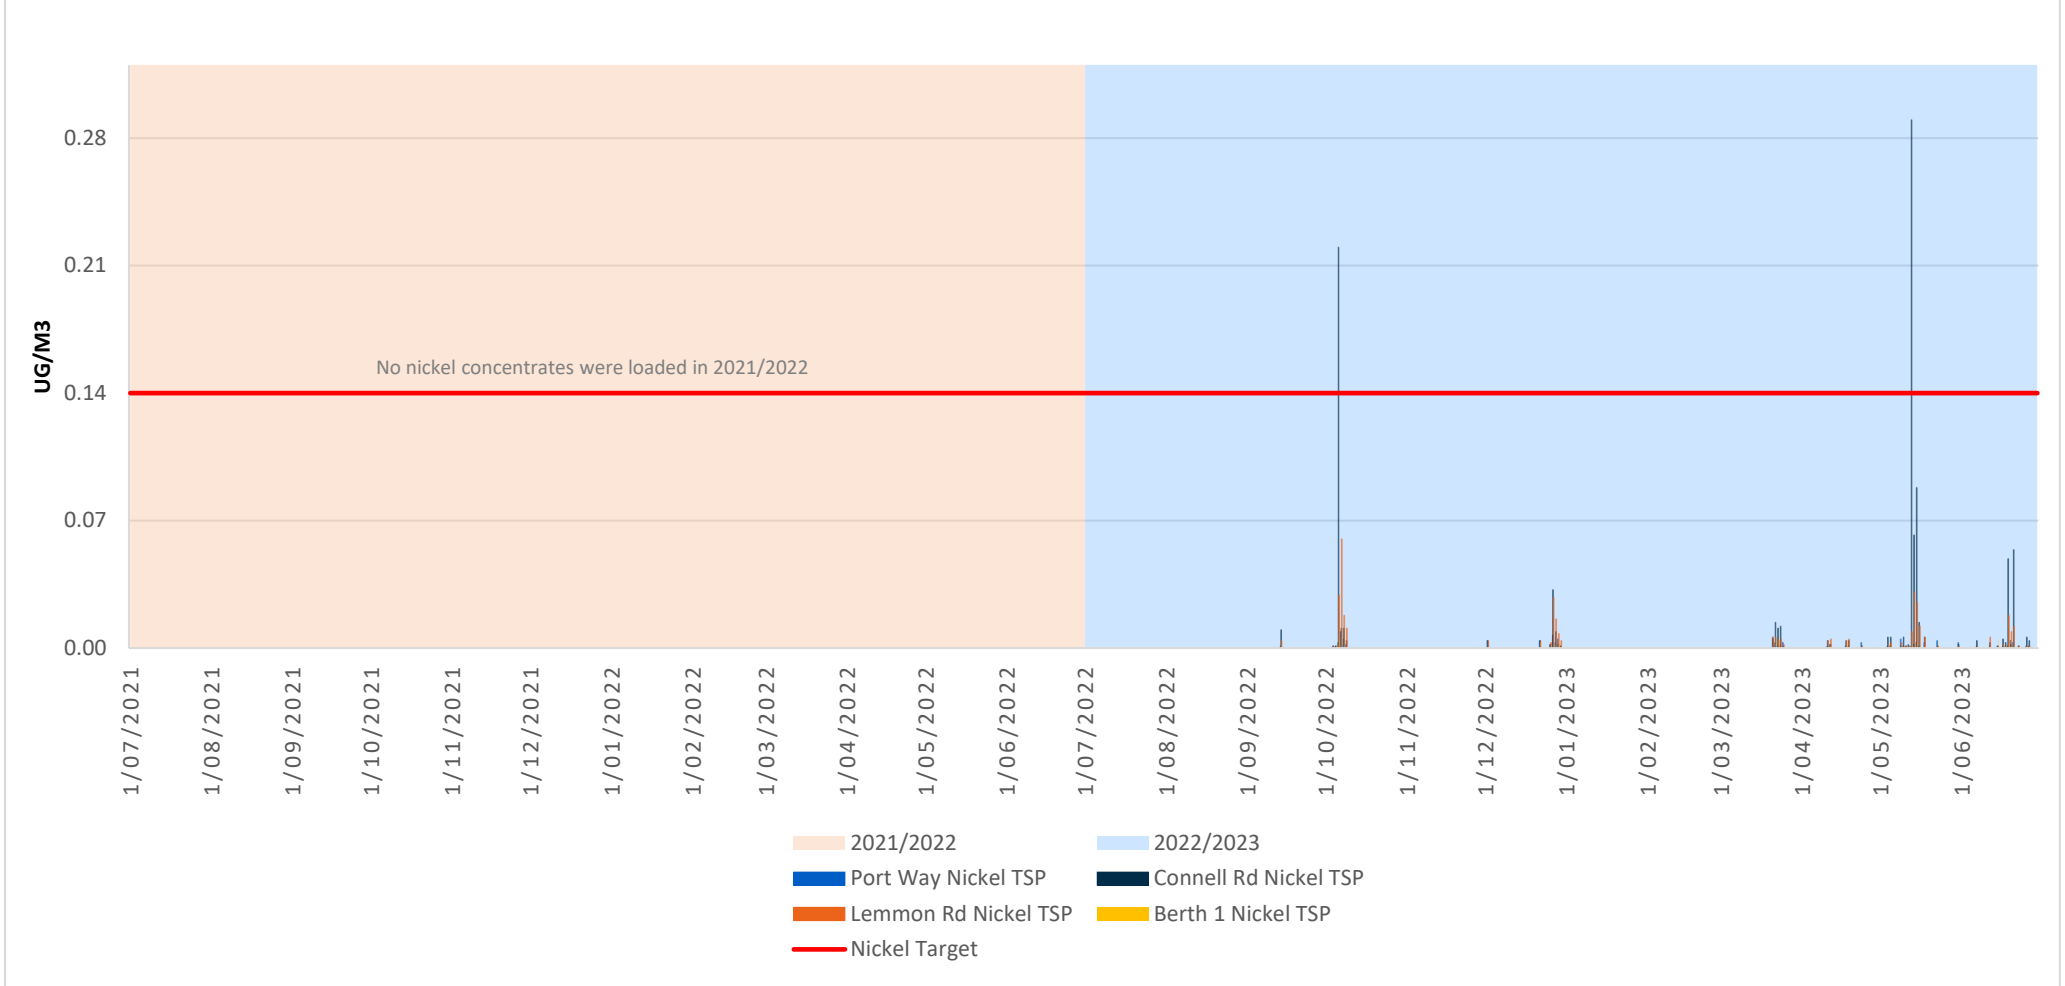
NICKEL TSP
ENVIRONMENTAL LICENCE TARGET = 0.14 UG/M3

Figure 11 - 2021/2022 and 2022/2023 Nickel Levels in Dust as PM10

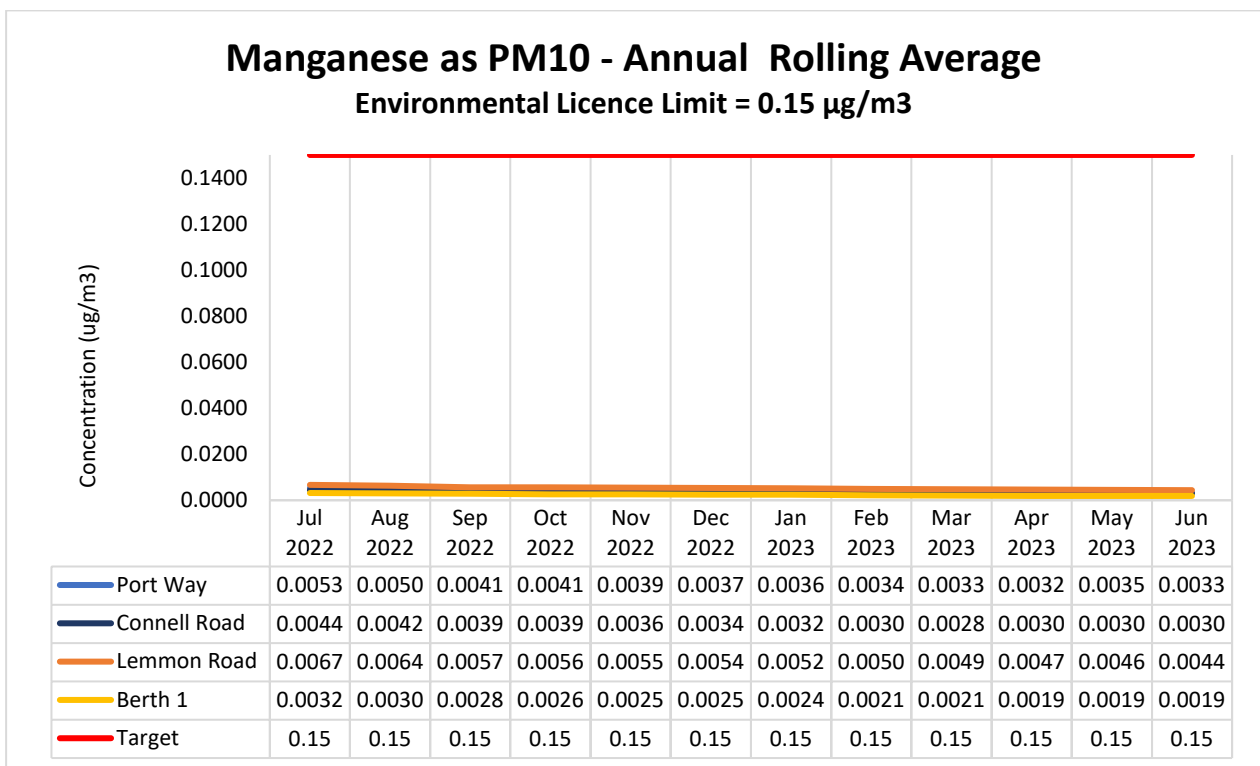
Figure 12 - Annual Rolling Average Manganese as PM₁₀

Figure 12 displays the annual rolling average for manganese as PM₁₀. All recorded levels are below the licence target level of 0.15 µg/m³.

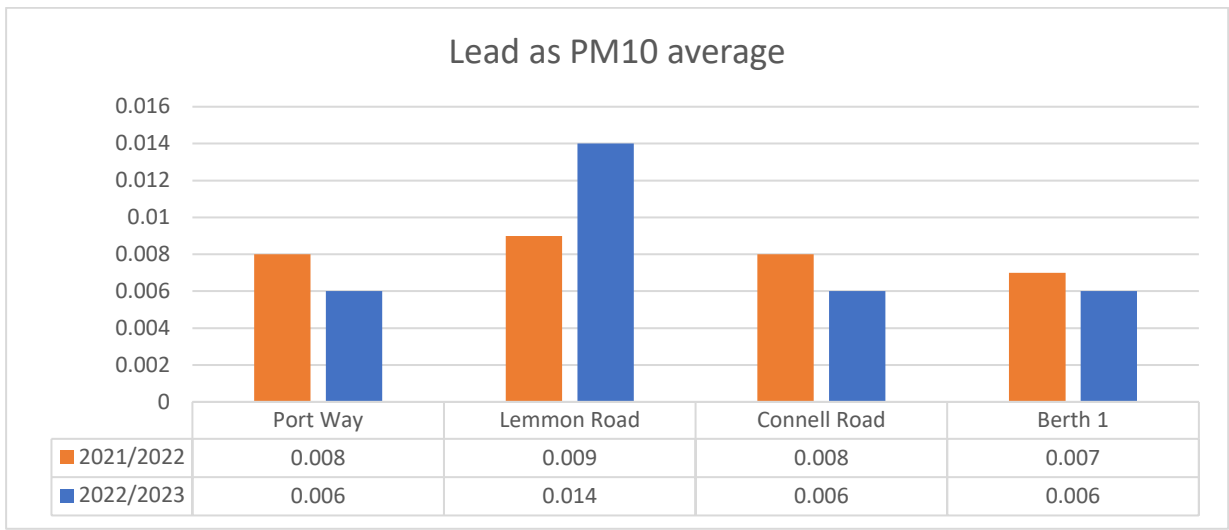
Figure 13 – Annual Average HiVol Lead as PM10

Figure 13 displays the annual average concentration of lead in HiVol samples for each monitoring location. Figure 14 displays each individual result for lead as PM₁₀ in 2021/2022 and 2022/2023.

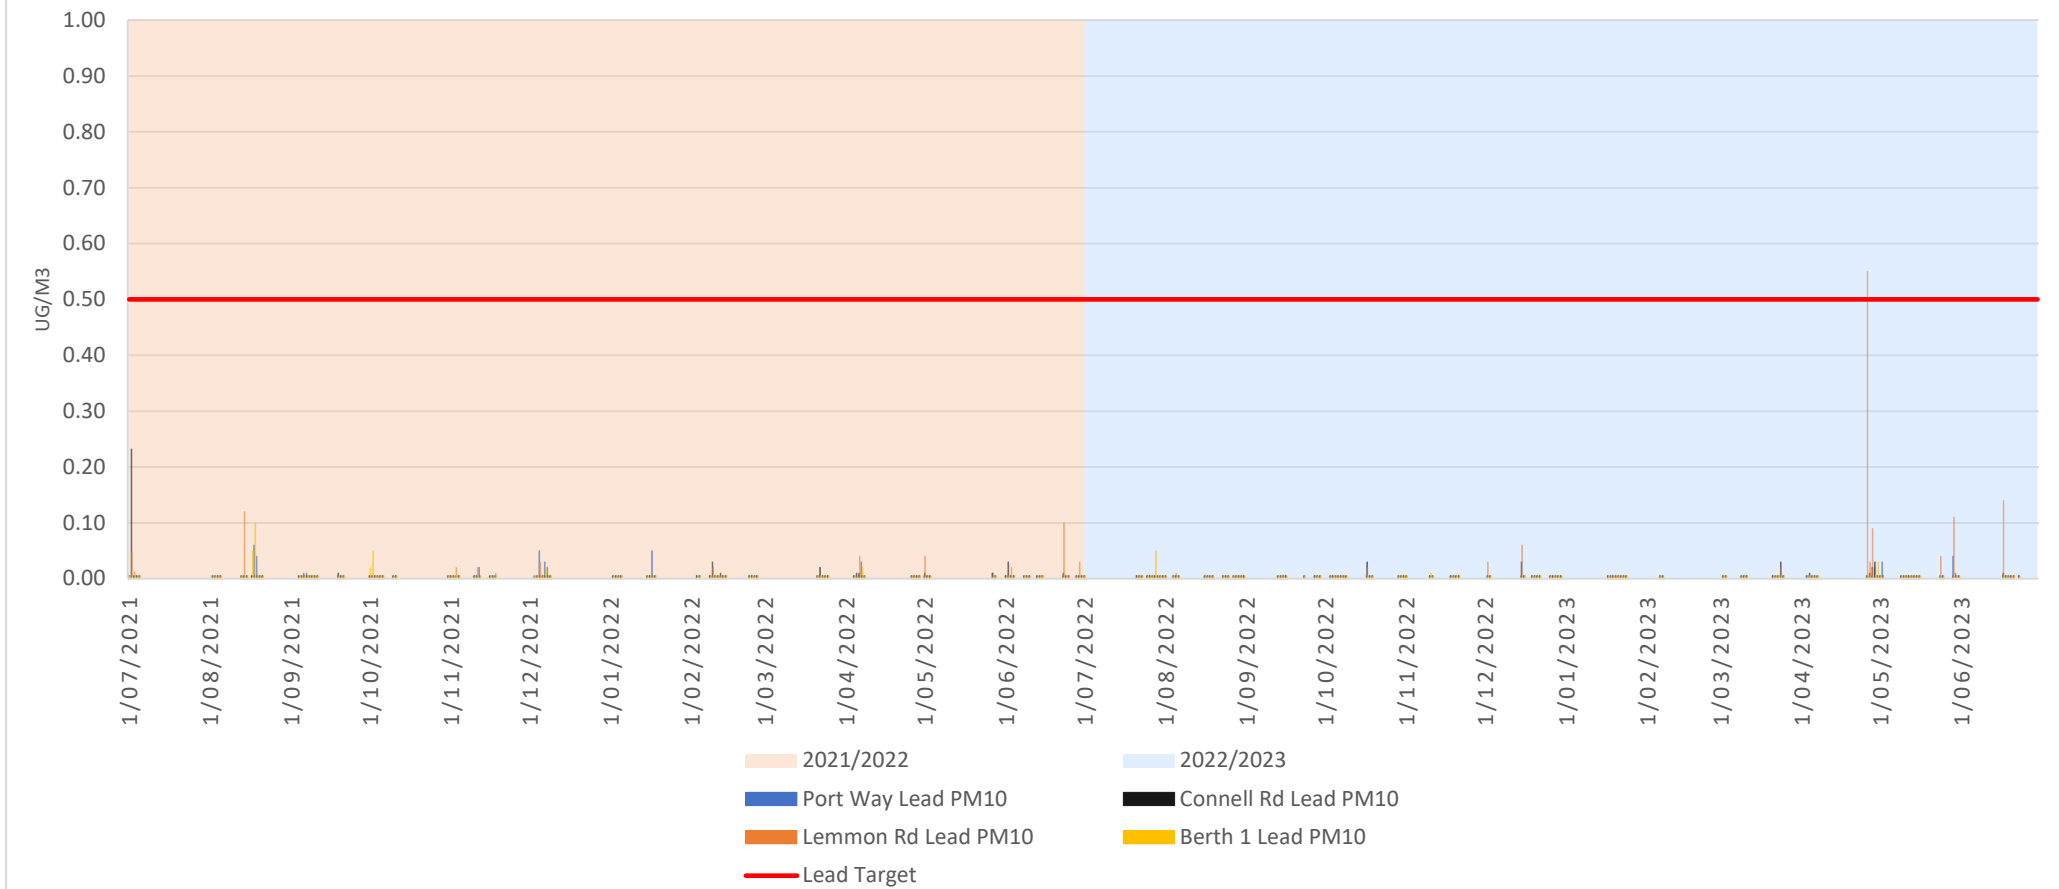
LEAD AS PM10
ENVIRONMENTAL LICENCE TARGET = 0.5 UG/M3

Figure 14 - 2021/2022 and 2022/2023 Lead Levels in Ambient Air as PM₁₀

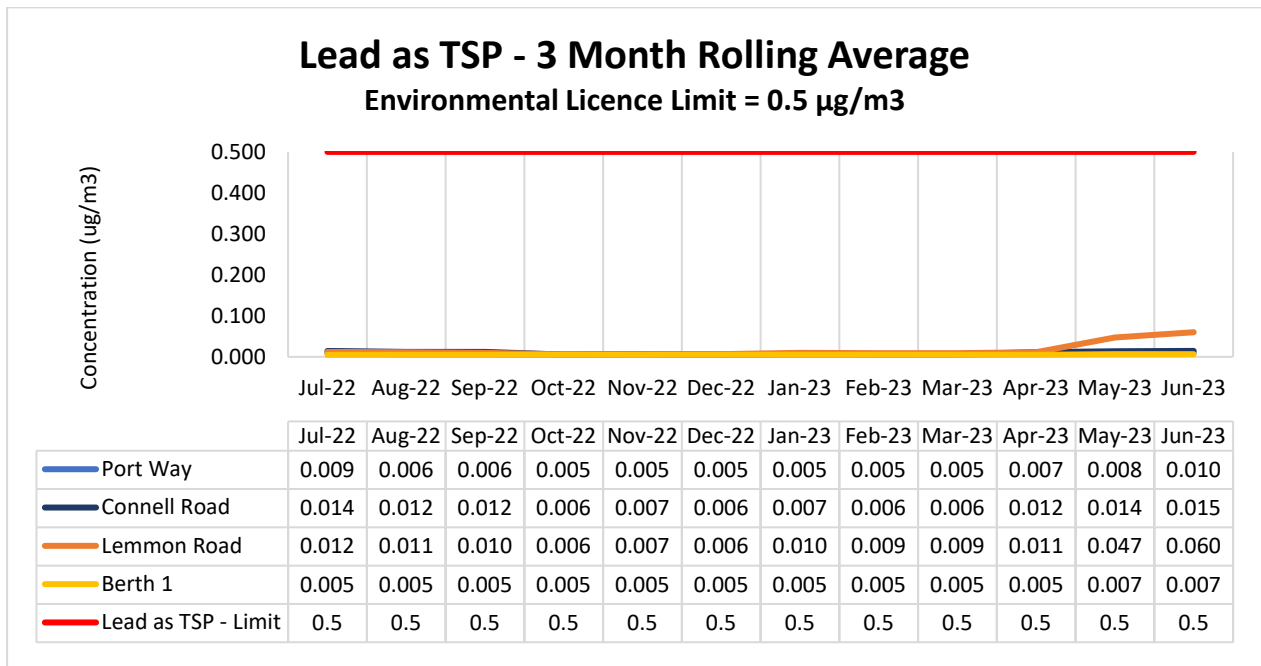
Figure 15 - Three Month Rolling Average Lead as TSP

As displayed in Figure 15 the 3-month rolling average for lead as TSP remained well below the licence limit of 0.5 µg/m³. The maximum 24-hour TSP level recorded was 2.9 µg/m³ at Lemmon Road in April 2023, which resulted in a small increase in the 3-month rolling average for the following two months.

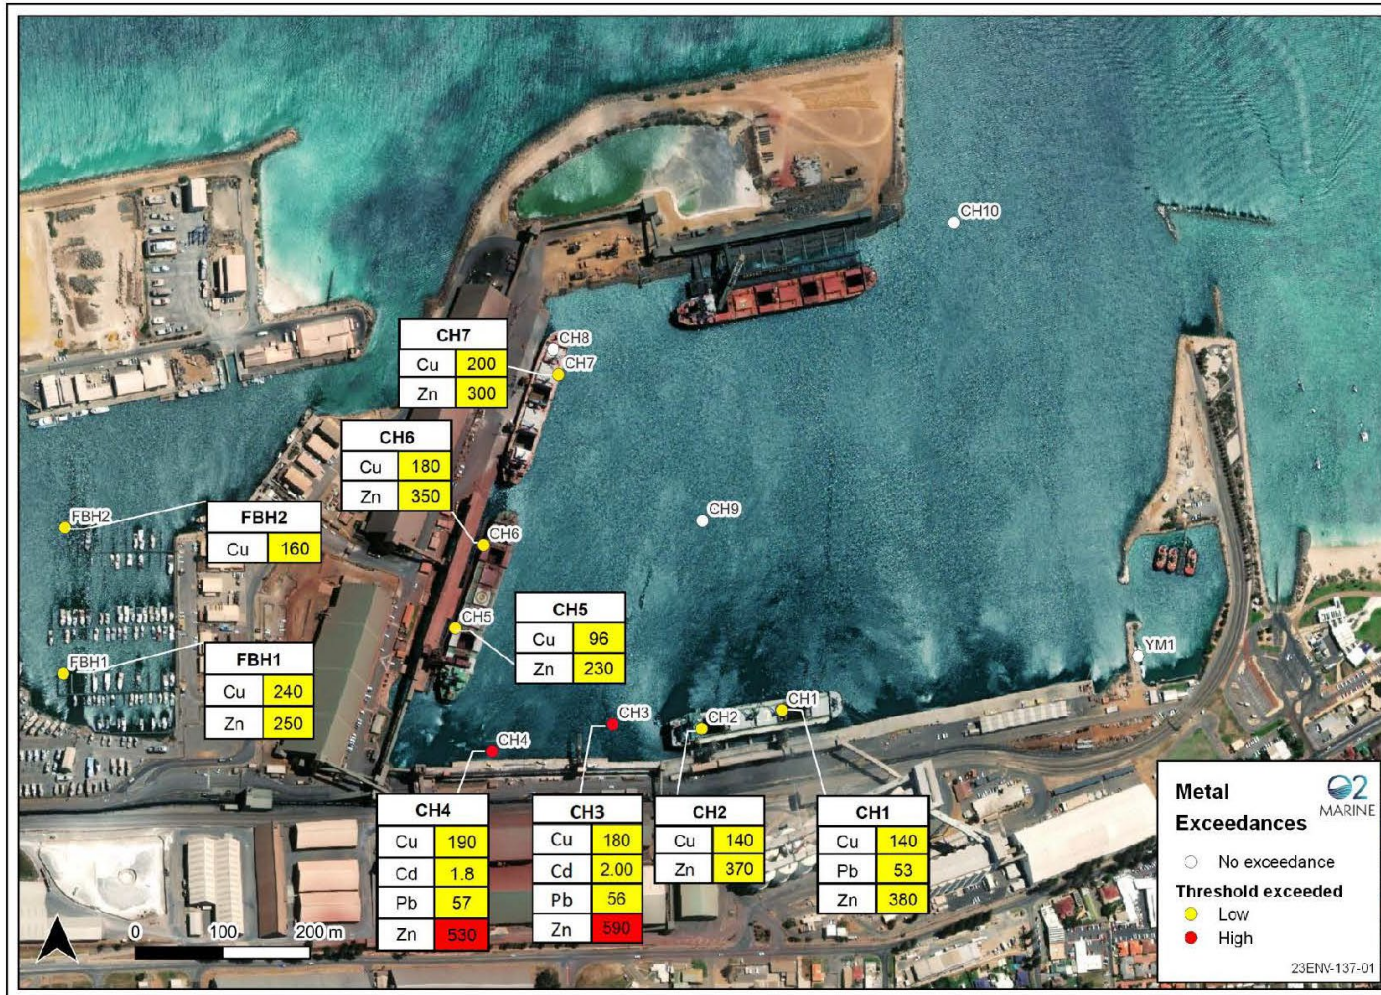
Figure 16 - Geraldton Port 2023 Sediment Sampling Locations and Metal Concentration Exceedances

Figure 16 shows metal concentrations (mg/kg) and exceedances of ANZG (2018) guideline values. Guideline values exist for arsenic, cadmium, copper, lead, mercury and nickel. No ANZG guideline values exist for iron, aluminium or vanadium.

Table 9 provides an overview of the 2023 exceedances of toxicant default guideline values (DGV) and the upper guideline values (GV-High) for the metals where ANZG 2018 guideline values exist. The exceedances are presented spatially in Figure 16.
